Hindcasting the waves at the Mulberry Harbours

The Harbours

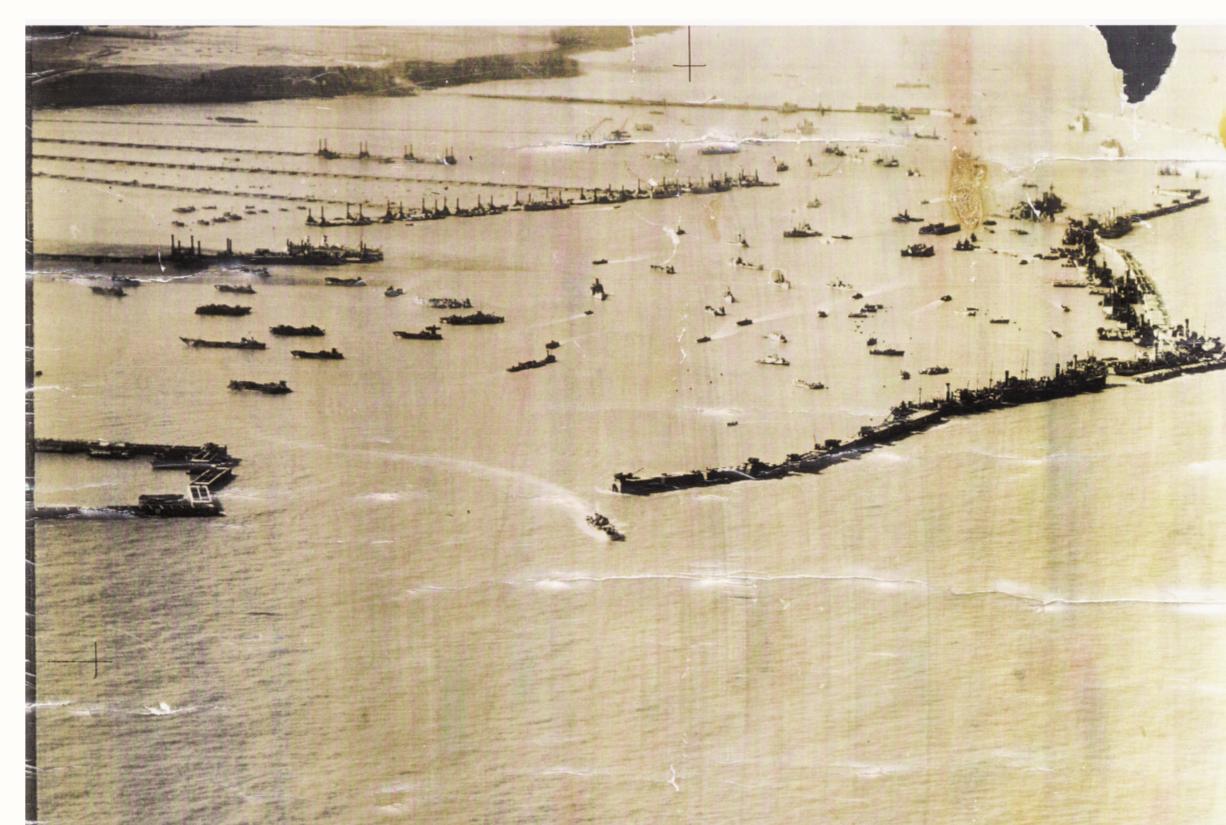
Figure 3: Mulberry B from the air.

Running up the beach were floating roadways ('Whales') over which transport vehicles and tanks could drive. These were designed to be compliant so that they would move with the waves and tide rather than trying to resist the motion. These connected to pierheads ('Spuds') which could be raised and lowered with the tide in a similar manner to a modern jack-up rig.

A variety of approaches were used for the breakwaters. In relatively shallow areas old ships were scuttled. In

deeper water 'Phoenix' caissons were used. These were towed across the channel and sunk in place. Finally, an outer floating breakwater (the 'Bombardons') was used to give extra protection and increase the area of tranquil water.

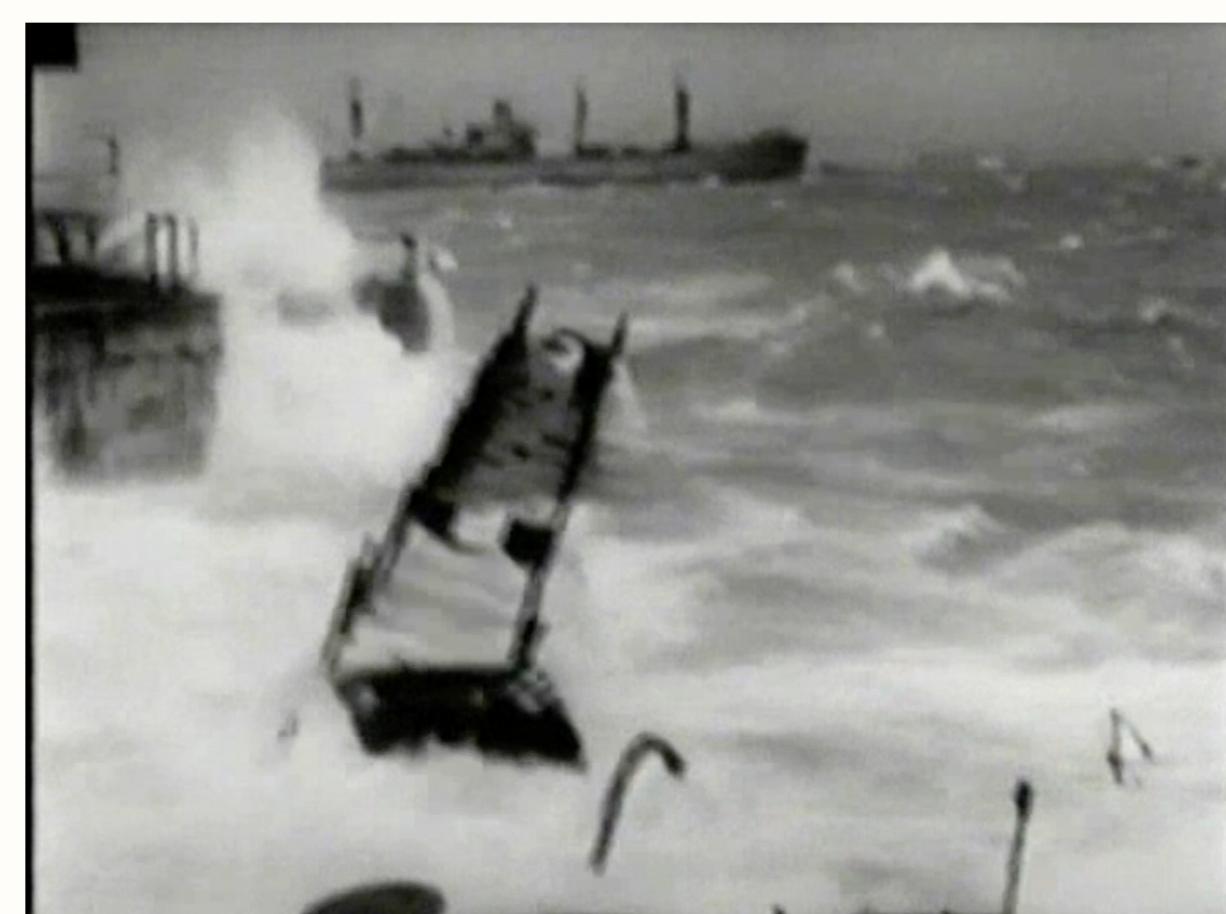
14 days after D-Day, when the harbours had just been installed, a major storm occurred. The storm destroyed the American Mulberry but, although badly damaged, the British harbour survived. Figure 4 shows one of the floating breakwaters which broke loose near the caissons at the British Mulberry.

Figure 4: A Bombardon broken loose in the storm.
